**RESEARCH REPORT**

**Reinforcement Corrosion Initiation  
and Activation Times In Concrete  
Structures Exposed To Severe  
Marine Environments**

***R.E. Melchers and C.Q. Li***

**Research Report No. 269.11.08**

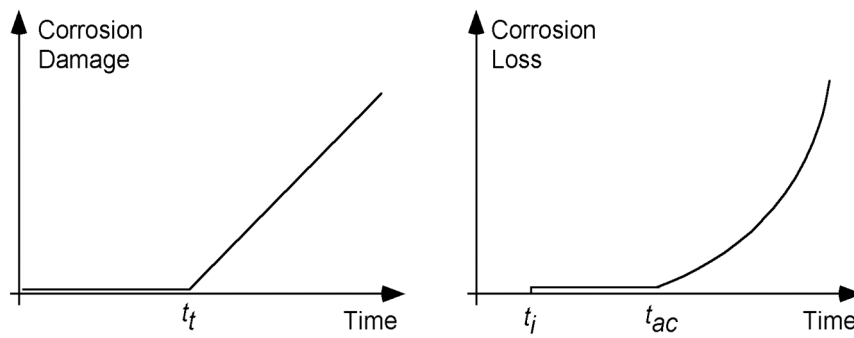
Figure 1(a) Bi-linear ‘damage’ model showing the threshold time  $t_t$  prior to which no damage is assumed to occur and subsequent to which linear damage accumulation is assumed, (b) more sophisticated model in terms of corrosion of the reinforcement showing the time  $t_i$  at which corrosion initiation occurs and the time  $t_{ac}$  at which long-term corrosion is activated [22].

In applications of the bi-linear damage model it is customary (and conservative) to assume that the cessation of adequate structural performance occurs at the onset of significant damage, that is, at time  $t_t$  (Figure 1a). This threshold of unacceptable damage is linked to a threshold chloride level, or, in other treatments, to a threshold ratio of the concentrations of chlorides to hydroxides at the reinforcement. The implication is that low levels of chlorides would not initiate corrosion. However, there have been many reports of reinforcement corrosion having initiated much earlier, as evident by rust stains and minor surface cracking sometimes with rust stains but with little or no evidence of further corrosion until much later (e.g. [23]). For this reason it is appropriate to add an earlier threshold, that of corrosion initiation, at time  $t_i$  and to distinguish this from active corrosion that occurs at a subsequent time  $t_{ac}$  (Figure 1b) [22].

Within the limitations of the available information, the present analysis shows that with  $t_i$  and  $t_{ac}$  as defined herein (Figure 1b) all of the longer  $t_i$  appear to be associated with the use of blast furnace slag cement or with some form of calcareous material for aggregates, such as seashells, limestone or (non-reactive) dolomite aggregates in the concrete. Similarly, the time  $t_{ac}$  to active corrosion is seen generally to be much longer for the concretes made with calcareous material or blast furnace slag cement. Moreover, the interval between  $t_i$  and  $t_{ac}$  is greater, typically, for the latter. These observations appear not to have been made previously.

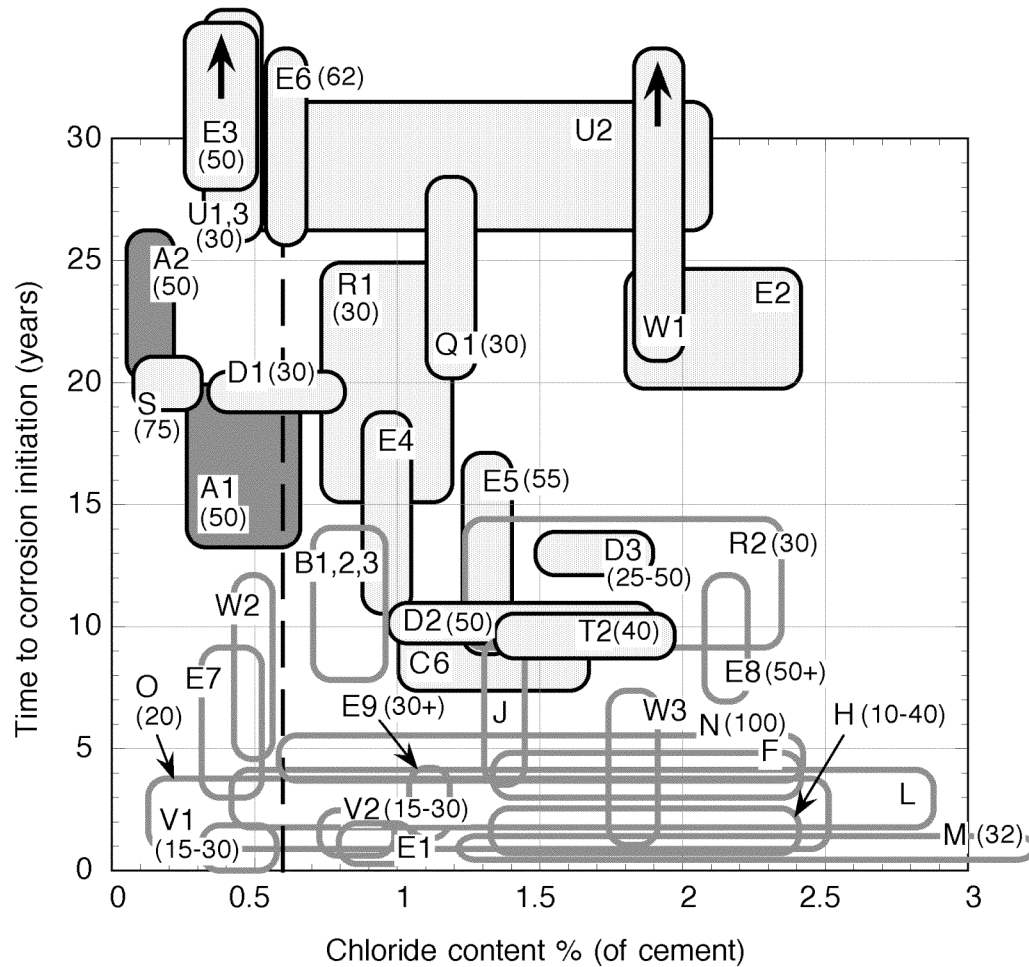
The dark shaded rectangles denote concretes made with blast furnace slag cements. The light grey rectangles denote concretes made with (non-reactive) dolomite or limestone aggregates or both or with seashells. The open rectangles are the remaining cases. Also shown is a typical nominal chloride threshold for corrosion damage, taken as 0.6% by weight of cement.

Figure 2 - Time  $t_i$  to corrosion initiation as a function of chloride content estimated at the level of the reinforcement for the cases shown in Table 1 for which information is available. Cases J and K, not shown, lie towards the bottom of the plot. Cover is 25mm unless shown otherwise (in brackets, mm).

Figure 2 shows that the time to corrosion initiation for ordinary concretes in many cases is quite short - within the first 5 years or so of exposure irrespective of the precise chloride content around the reinforcing bars, although for low levels of chlorides the initiation time appears to be generally somewhat longer - perhaps up to about 10 years. However, for the concretes containing limestone or (non-reactive) dolomite aggregate (or seashells (W1)) or blast furnace cement (A1 and A2), the times to initiation of corrosion are longer, and in some cases very much longer. Again lower levels of chlorides around the reinforcement appear to extend the time to initiation.

Figure 2 shows clearly that in general the initiation time  $t_i$  was quite short, typically occurring within a few years of first exposure. However, there are also a number of cases for which the initiation time was considerably greater. Commonly such differences have been dismissed and attributed to differences in concrete composition, in concrete quality and in cover to the reinforcement. Undoubtedly these factors will have influences on long-term corrosion behaviour of reinforcement. However, their influence is not consistent, with some structures with poor quality concrete or minimal cover displaying better corrosion resistance than others with high quality concretes and greater concrete cover. This inconsistency has been noted before [9,23].

Despite the information in Table 1 and Figures 2 and 3 being subject to considerable uncertainty, as noted above, collectively it points to a consistent trend, namely that elevated levels of calcareous material in the concrete mix may be linked to enhanced durability of reinforcement against corrosion. The information used in Table 1 (and the trends in Figures 2 and 3) suggests this inference but cannot validate it and this difficult task remains. Controlled long-term experiments with a range of concrete aggregates and identical exposure conditions were commenced (at Newcastle) three years ago in an attempt to provide further insight and independent confirmation but clearly longer-term information may not be available for several decades.

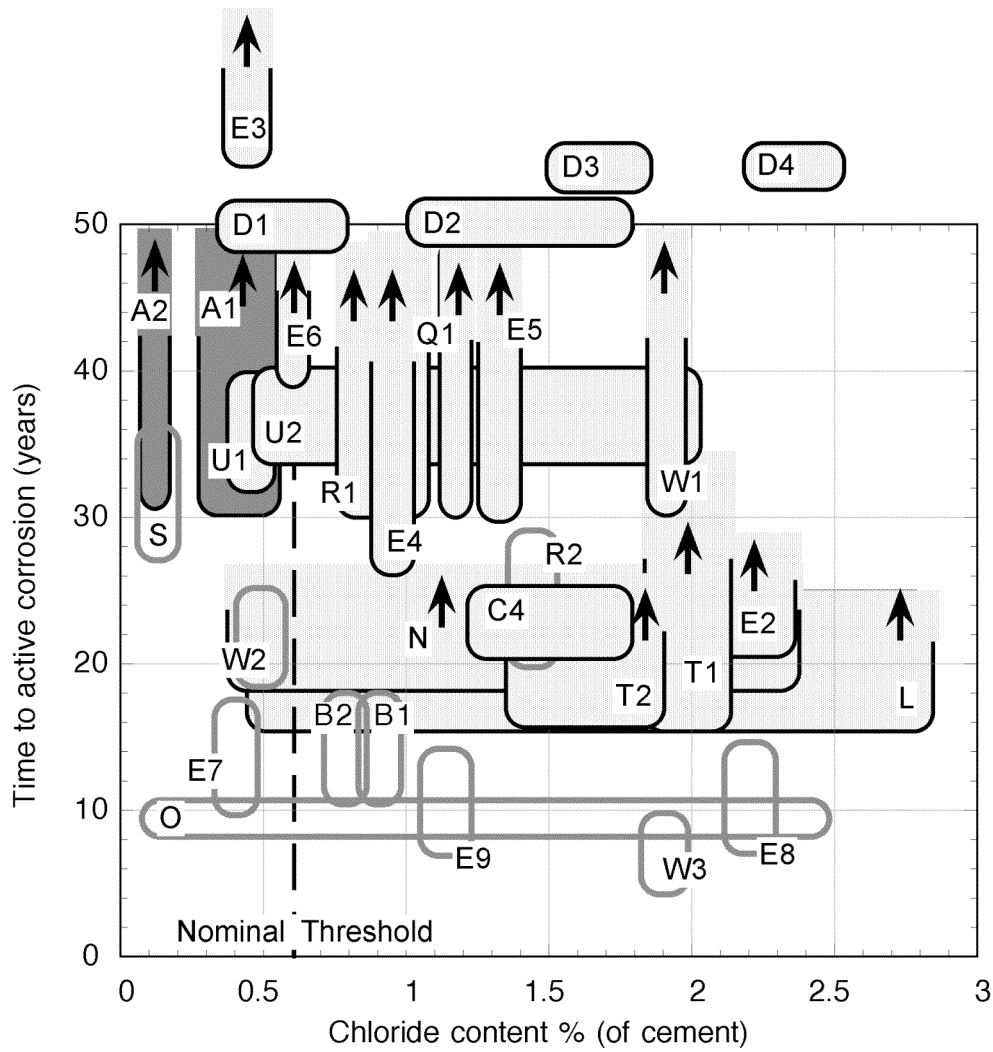
Figure 3 - Time  $t_{ac}$  to active corrosion as a function of chloride content estimated at the level of the reinforcement for the cases shown in Table 1 for which information is available.

For the time  $t_{ac}$  to active corrosion, Figure 3 shows a clear distinction between the structures constructed from ordinary concrete and those in which the aggregates contained limestone, dolomite or other forms of calcium carbonate. The ordinary concretes all led to active corrosion occurring within about 20 years of exposure, somewhat longer when the chloride content was lower. For the concretes containing limestone, dolomite, seashells or blast furnace cements the time to active corrosion was at least 15 years after first exposure (case L) and in most cases very considerably longer, with some cases showing no sign of active corrosion even after 60 years exposure.

Figure 3 does not discriminate for concrete cover. This is unlikely to have much influence on activation time since in most cases the reinforcement can be expected to be fully exposed to high levels of chloride (and moisture) in the surrounding concrete after 20 years or so.
