# **CORROSION OF ISOLATED AND ELECTRICALLY-CONNECTED STEEL COUPONS IN TEMPERATE COASTAL SEAWATER**

**Robert J Jeffrey and Robert E Melchers**  
**Centre for Infrastructure Performance and Reliability**  
**The University of Newcastle, Australia**

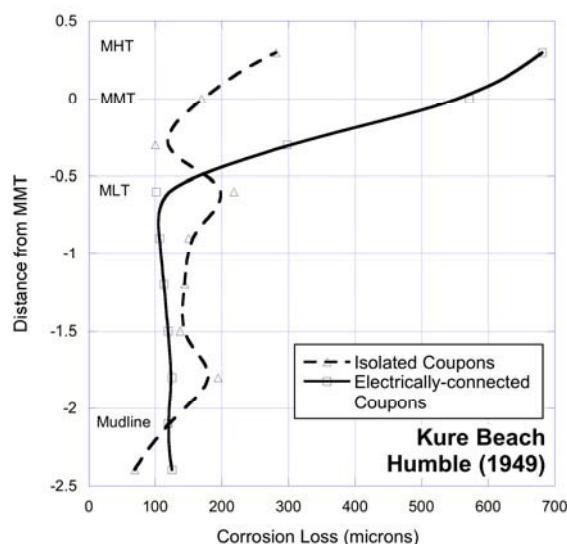
Figure 1 Corrosion profiles for coupled and isolated coupons exposed for about 6 months at Kure Beach, North Carolina. Trends based on data reported by Humble (1949).

Previous studies of steel coupons exposed in the coastal tidal zone appear to have commenced with Humble (1949) who reported corrosion losses for individual coupons as well as electrically-connected coupons. The complete trial consisted of 27 racks of coupons each rack with steels of different composition. The coupons were 300mm x 300mm in size and were exposed for about 6 months. The individual results derived from weight-loss measurements for untreated, sandblasted mild steel plates, coupled and uncoupled are shown in Figure 1. The corrosion profile is shown also. Note that the majority of the coupons were in the immersion zone, i.e. from mean high tide level, down to below the mud line. There are no panels in the atmospheric or splash zones. Even so, a significant difference is evident between the electrically connected and the isolated profiles in the vicinity of the mean water level. Both profiles have the greatest corrosion loss in the high water zone. There is also a higher corrosion loss at the mud line, some 1.8m below the MMT.

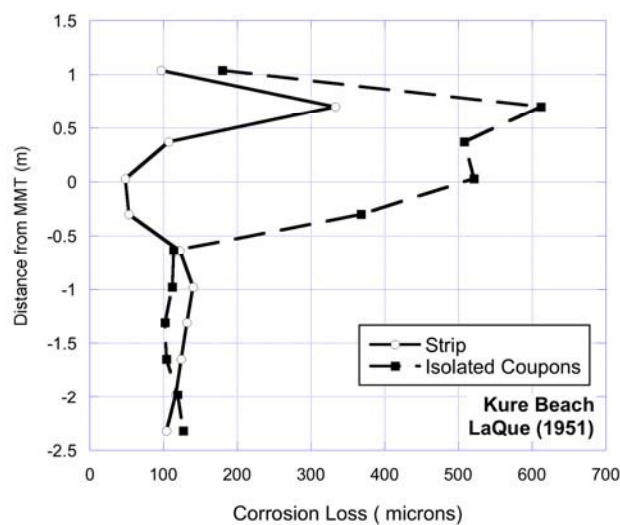
Figure 2 Corrosion profile as derived from exposed steel strip and individual coupons exposed for 151 days at Kure Beach, North Carolina. Based on data reported by LaQue (1951).

Tests at the same test location (Kure Beach, North Carolina) but this time for isolated coupons and for continuous strips of mild steel were reported by LaQue (1951) for tests of 151 days duration (Figure 2). The coupons were 300 mm x 300 mm mild steel plates and the strip was 300 mm wide and 6m long. Corrosion loss was derived from mass loss, with the steel strip sectioned into 300mm lengths. It can be seen that the greatest loss for both strip and panels about 500 mm above the mid-tide mark although the loss on the panels is almost twice that on the continuous strip. Below average low tide level corrosion loss is similar. It will be noted that on the strip profile there are distinct high water (between MMT and MHT) and low water (between MLT and MMT) preferential corrosion zones. LaQue (1951) attributed the differing corrosion loss to differential aeration cells and calcareous deposits.

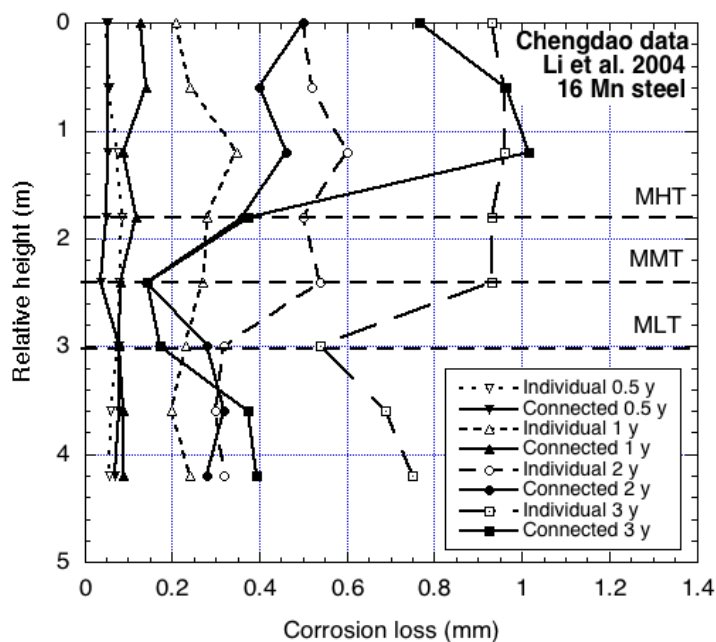
Figure 3 Comparative corrosion profiles for steel (16Mn) coupons isolated and electrically connected exposed at Chengdao Offshore Oil Exploration Area, based on data reported by Li et al. (2004). The profiles for other steels were generally similar.

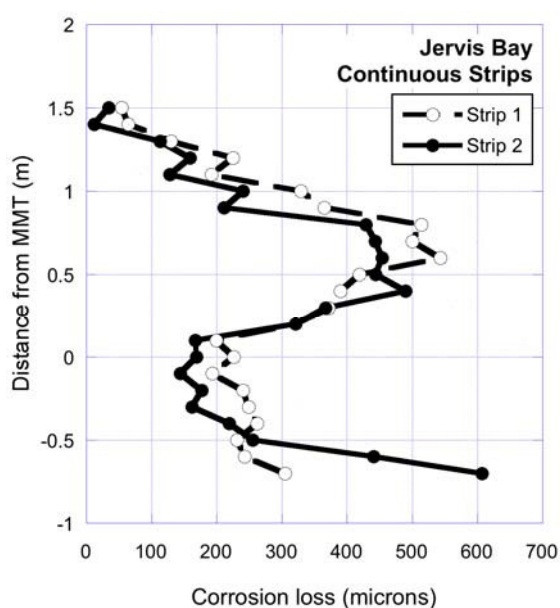
Figure 4 Corrosion profiles for strips

The data points and the corrosion profiles obtained from them for the two strips are shown in Figure 4. Similarly, the data and the profiles for the insulated and for the connected coupons are shown in Figure 5.

Evidently, the profiles in Figure 4 are very similar, both showing a distinct increase in corrosion loss in the upper tidal zone and at the lowest section of the strip, consistent with the profiles reported previously (Jeffrey and Melchers 2008). The increased loss above mid tide level has been attributed to maximum availability of the two key factors governing corrosion – availability of oxygen and the presence of a suitable electrolyte. Strips that are embedded in the river or sea bed tend to have a relatively even profile below the annual low tide level – as reported by Humble (1949) and Laque (1951). The addition corrosion loss at the lowest section of the strips reported here has been observed also on strips that are suspended only from the top and are relatively free to move with the current (unreported observations).

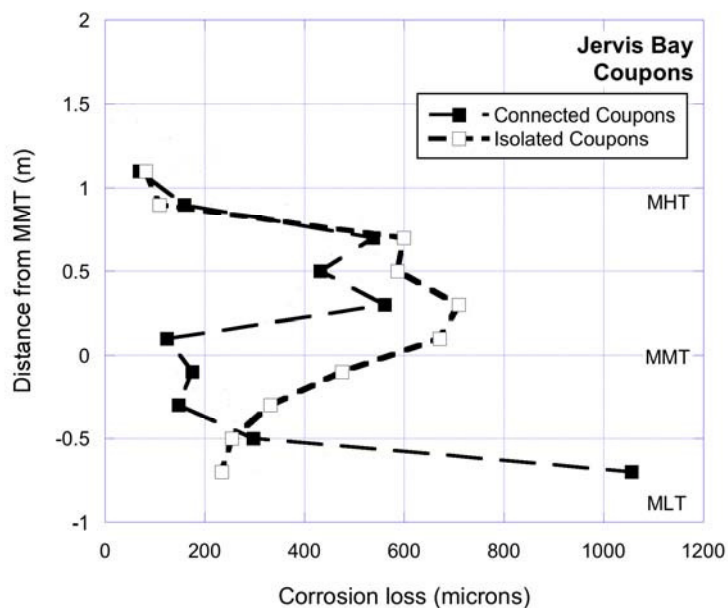
Figure 5 Corrosion profiles for insulated and connected coupons

The corrosion profiles obtained from the corrosion losses of the two sets of coupons are shown in Figure 5. The corrosion losses in the atmospheric zone are almost identical. Between the maximum high tide level and lowest low tide level (the tidal zone) the profiles are similar but the losses on the isolated coupons are up to twice those of the connected coupons.

Losses at low tide level are very similar. However, in the immersion zone, the few coupons exposed here show very different corrosion losses, with the electrically connected coupons having losses at the lower extremity almost five times those of the electrically isolated coupon. The reason for this difference is unclear. One possibility may be an anodic effect as a result of the coupons being connected to the other coupons. In this case a similar effect might be expected for the strips – indeed these also show evidence of very high corrosion losses at the ends. Shorter strips, not covering the entire vertical range as in Figure 4, also have been found to show a generally similar but less severe effect (Jeffrey and Melchers 2009).

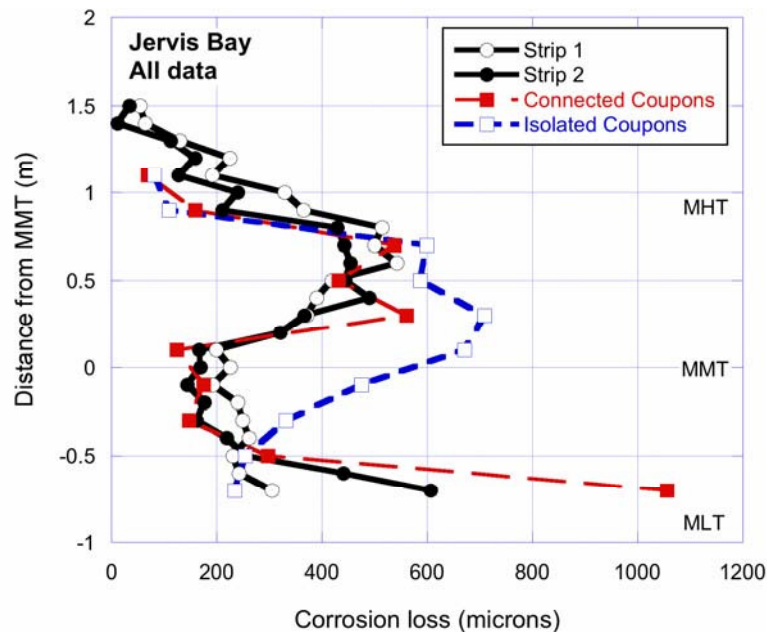
Figure 6 Comparative corrosion profiles for strips and coupons exposed at Jervis Bay.

Figure 6 gives a comparison of all the data and all trends. It is apparent that apart from corrosion loss on the lowest connected coupon, the corrosion profile derived from the electrically connected coupons is similar to that of the steel support strips.

When the results shown in Figures 4-6 are compared with the classical profiles of Humble (1949), LaQue (1951) and Larrabee (1958) as well as the profiles published by others subsequently, it is clear that the profiles for isolated coupons are all very similar, irrespective of location. Similarly the results for electrically connected coupons are similar to those for continuous strips and also are similar to the classical profiles. Thus it may be concluded that the profiles for the classical results all likely to be applicable to unpolluted coastal seawaters, a matter not previously clarified as water quality was not defined and in some cases there could easily have been local water pollution. Given this conclusion it becomes possible to use the available information together with the Jervis Bay and other data being collected on the east coast of Australia
