# Corrosion of steel and other wreckage in the Belgian North Sea

SUMMARY: The near-coastal strip of the North Sea off Belgium has some three hundred shipwrecks mostly of steel construction, dating from both World Wars. Because many contain the remains of their crews and others, they are protected by Belgian law. Besides their cultural and historical value, these wrecks have a biological, environmental and economic importance. Preservation of the wrecks is an on-going issue. To-date, the rate of deterioration of the wrecks has been determined by comparing measured in-situ steel plate thickness with archived information about the ships' construction. The most applicable and general corrosion models are being used as a benchmark. The Melchers' corrosion model compared with the in-situ measurements showed a discrepancy that currently cannot be explained. This is important because the actual and likely future wreckage corrosion rate is required to refine our current view on the defining parameters for long term steel corrosion in stationary structures in the North Sea and also important for deciding how to preserve these wrecks for future generations. When validated against the in situ

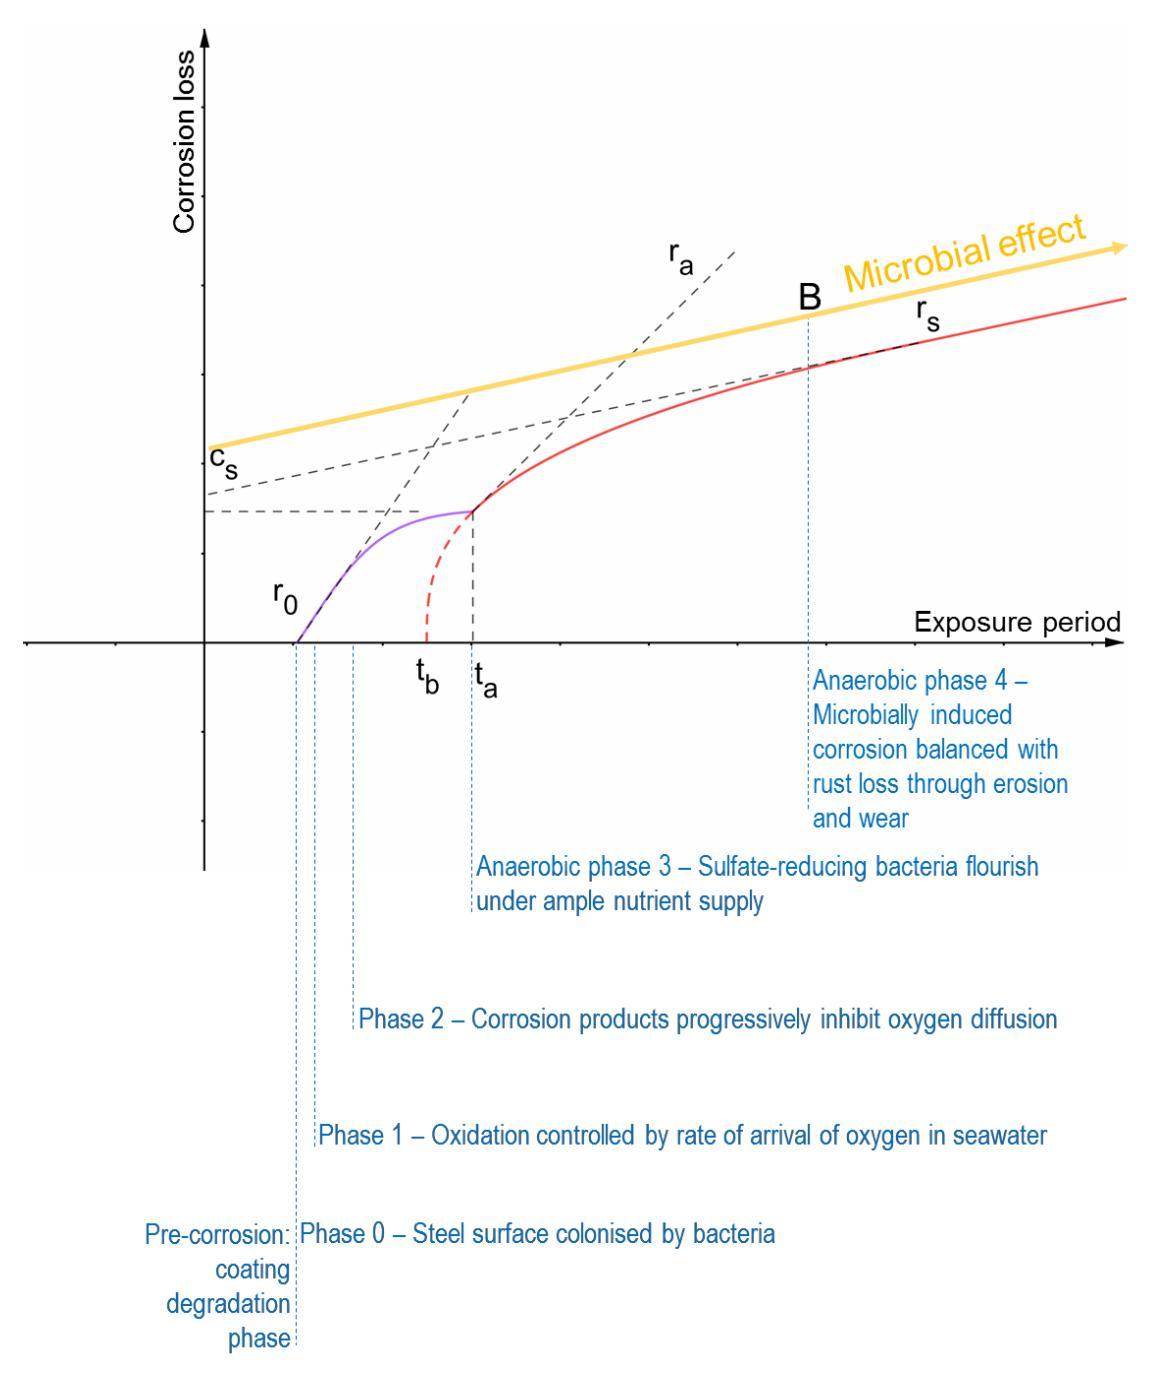
Figure 1. Multi-phase model for long-term corrosion in marine environments showing the parameters defined in the text and in Table 1. The long-term corrosion rate becomes linear at t > B, due to a possibly increasing importance of microbiological influences over the involvement of oxygen. (based on Melchers, 2014).

This study applies the bi-modal model (Melchers, 2003), largely because it is based on physical and electrochemical principles. The model is robust and takes into account uniform as well as pitting corrosion in aerobic and anaerobic conditions, bacterial, environmental and manmade influences. In the model, five phases can be discerned (Figure 1). Phases 0, 1 and 2 are predominantly oxygen controlled while phases 3 and 4 are anaerobic. In the idealized case, the aerobic corrosion process starts with an initial instantaneous corrosion rate r0. Due to a progressive lack of oxygen, this rate diminishes and becomes nearly zero. At  $t_a$ , however, the corrosion rate picks up again under the influence of anaerobic and possibly bacterial corrosion processes with an initial corrosion rate of  $r_a$  to reach a constant rate  $r_s$  at time point B.

For long-term corrosion (t >B) processes, the Melchers model described in the introduction can be simplified to become a linear curve with slope rs and intercept cs (Figure 1):

The Melchers model was parametrised for the North Sea, with parameter values as estimated and presented in Figure 1 based on the equations in Table 1. As most of the wrecks of interest have been immersed for a very long time (> 15 years), it is permitted to use the linear approximation of the Melchers model (Eq. 1).

Under anaerobic conditions, the corrosion model (see Figure 1) involves a steep increase of corrosion loss starting from  $t_a$ , followed by a linear phase. The exact value of  $t_a$  may depend on environmental conditions and cannot be accurately estimated from the data at hand, as all considered shipwrecks have been immersed during many years; the minimum time of immersion being 43 years (Sabrina II). The first preliminary phase to be considered is a period preceding the actual multiphase model of Melchers, being the time frame during which the metal structure is still protected by a coating. The durability of coatings on shipwrecks has never been studied in detail. Even estimating the durability of modern coatings poses significant problems. A survey by Verstraelen et al. (2009) suggested that, on average, ballast tank coatings remain sufficiently intact for a period of 10.1 years. Calculations based on the equations given in Table 1 give a time interval between  $t_0$  and  $t_a$  of approximately 2.2 years, so that  $t_a$ . = 12.3 years (taking into account an intact period of 10.1 years) is considered a reasonable value for this research. The non-linear part was thus fitted to the data based on the theoretical value of  $t_a = 12.3$  years.

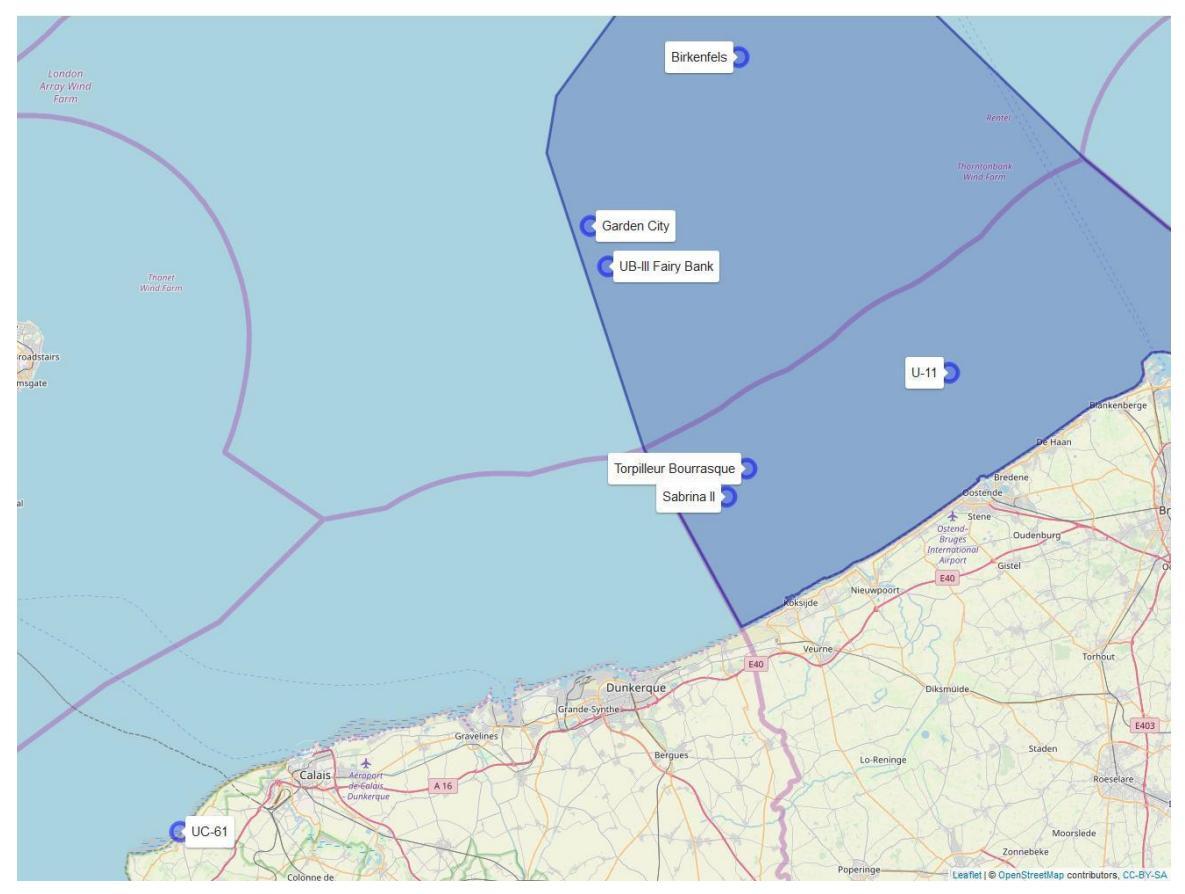
Figure 2. Position of the wrecks used in this study, in the Belgian Part of the North Sea and the French coast

The Belgian part of the North Sea (BPNS, as defined, for example, by (Lescrauwaet, et al., 2013) contains numerous shipwrecks from a variety of sources and ages (see http://www.maritieme-archeologie.be/). Six of these wrecks (Table 2) were selected on the basis of a number of criteria such as water depth, under water visibility, general condition and position of the wreck on the sea bottom, distance from shore, surface traffic density, location in or outside protected or restricted area, availability of dive charters and, most importantly, the availability of reliable original construction data. The seventh wreck, the submarine UC-61, was found in very shallow coastal water near Wissant (France). Most of the time this wreck is immerged, but tidal effects and sand displacement may exceptionally allow the wreck to become visible and accessible at low tide. The wreck was visited on January 19, 2019. As the specific date at which each of the ships sank is known (Table 2), the duration of the immersion could be determined exactly.

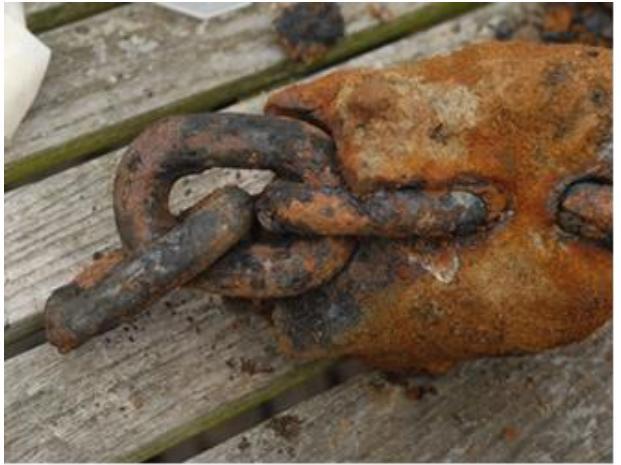
Figure 3. Chain used for DNA sampling and XRD analysis of the concrete layers. Corrosion & Prevention 2019 Paper 076 - Page 8

To obtain a clear view on the possible influence of MIC on the anaerobic corrosion rate at the bottom of the North Sea, it was attempted to determine the presence of bacterial cells or their metabolic end products. To this end, destructive sampling was needed. As it is morally and legally impossible to collect pieces of shipwrecks, samples were taken from a metal chain shown in Figure 3), not belonging to one of the shipwrecks, and salvaged in March 2018. Little is known about this piece of chain except that it has been on the bottom for a very long time, in any case more than 15 years.

To assess the presence of SRB, DNA sampling was attempted from the concrete layer around this iron chain shackle. The extraction yielded very low DNA concentrations and the subsequent PCR of 16S rRNA genes did not result any amplification of the genetic material (data not shown), probably due to very low amounts of bacteria and the presence of inhibitory compounds. Moreover, XRD analysis of a piece of an iron chain conserved under the same conditions as the shipwrecks in the rest of the study, however, indicates that the metal concretion (Figure 4A) probably contains SiO<sub>2</sub>, CaCO<sub>3</sub>, K<sub>2</sub>CaMg(SO<sub>4</sub>)<sub>3</sub>, FeO(OH), K<sub>3</sub>FeO<sub>2</sub>, Fe<sub>0.94</sub>O, CaFeO<sub>3</sub> and Fe<sub>8</sub>O<sub>8</sub>(OH)<sub>8</sub>Cl, whereas a seabed sample taken close by (Figure 4B) contained mostly CaCO<sub>3</sub> and K<sub>2</sub>CaMg(SO<sub>4</sub>)<sub>3</sub>. This analysis failed to demonstrate the presence of iron sulfides, which could function as a proxy for the historic presence and metabolic activity of SRB.

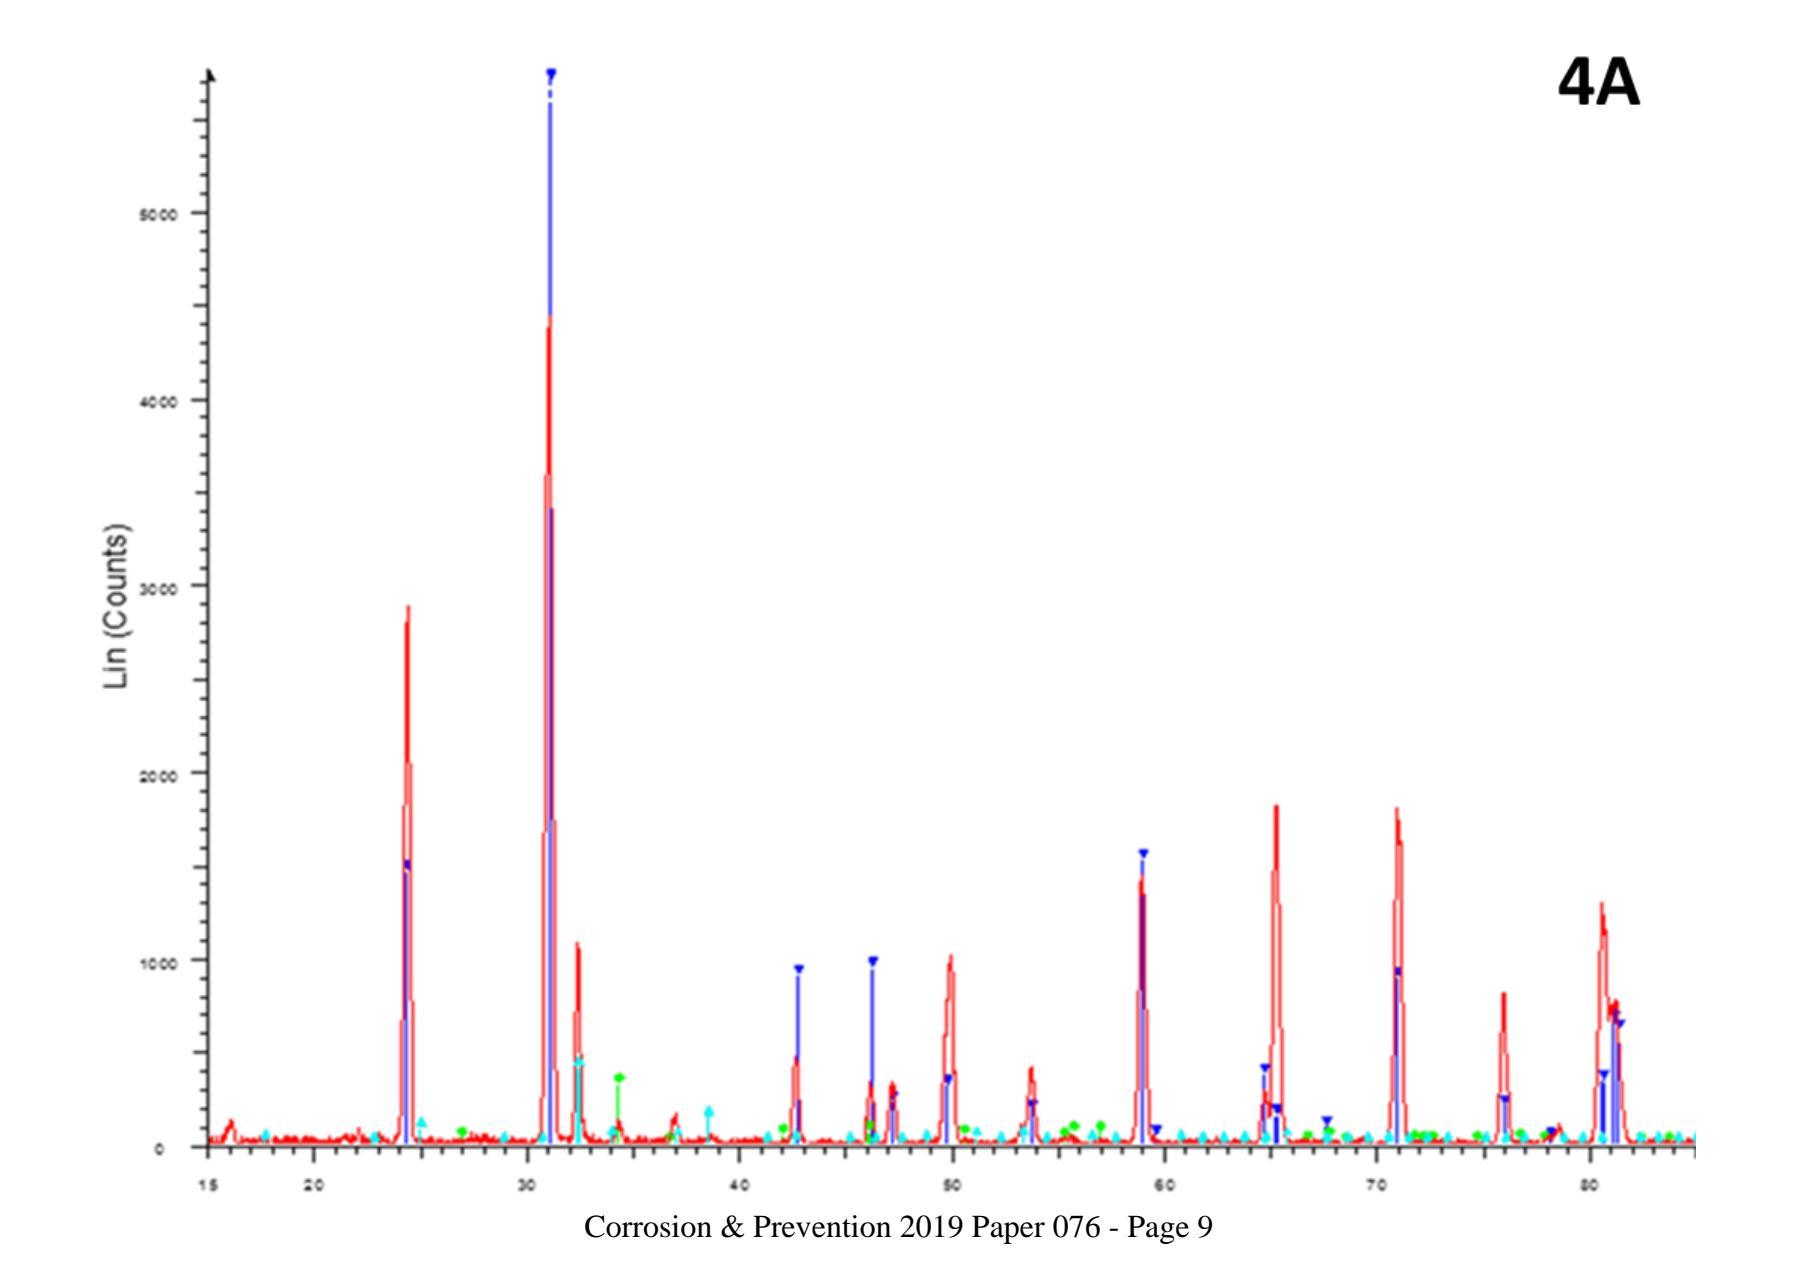
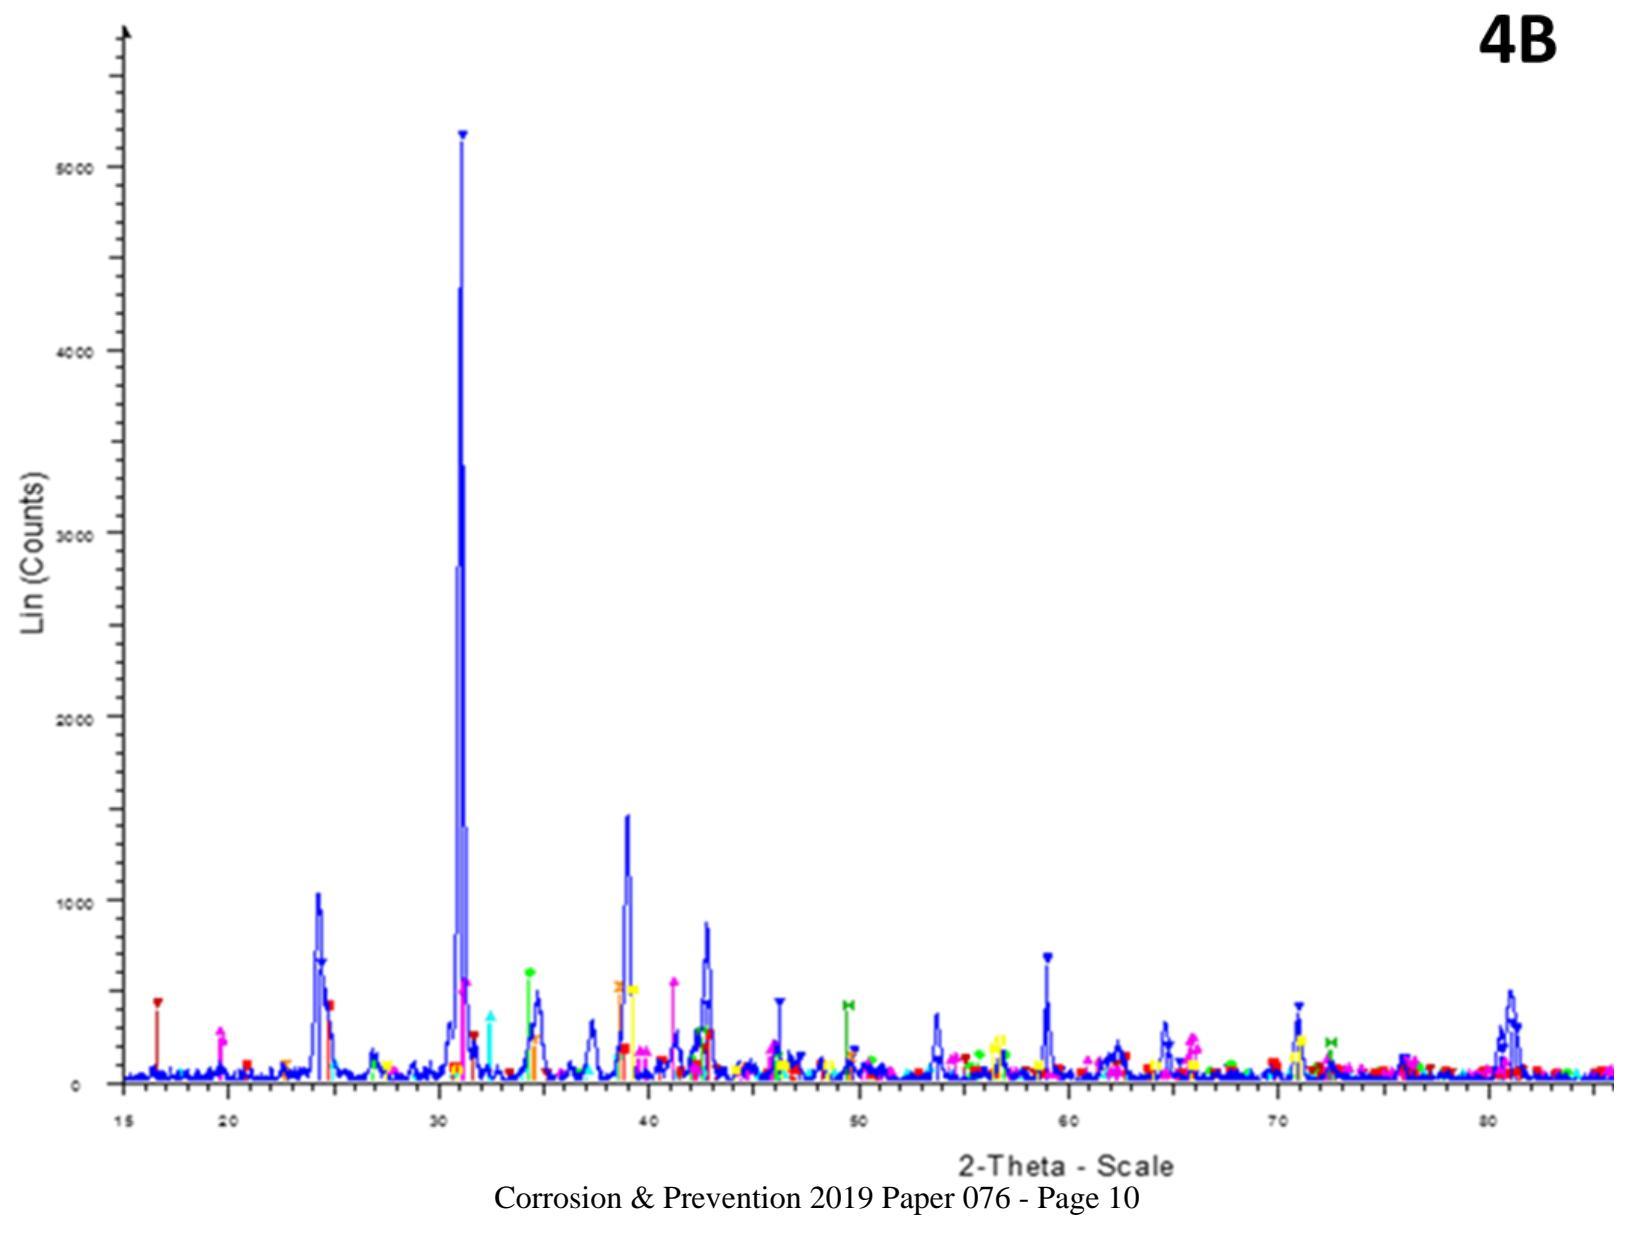
Figure 4. XRD analysis of (A) corrosion concrete depositions around a metal chain shackle retrieved from the bottom of the North Sea as well as (B) the surrounding sediments on the seabed. Red line represents raw data in figure 4A; blue line represents raw data in figure 4B. In both A and B, composition can be read as: Blue triangles: SiO<sub>2</sub>. Light green dots: CaCo<sub>3</sub>. Light blue triangles: K<sub>2</sub>CaMg(SO<sub>4</sub>)<sub>3</sub>. Red squares: Goethite (FeO(OH)). Dark red triangles: Lepidocrocite (FeO(OH)). Orange cross: K<sub>3</sub>FeO<sub>2</sub>. Dark green cross: Fe<sub>0.94</sub>O. Yellow: CaFeO<sub>3</sub>. Magenta triangle: Fe<sub>8</sub>O<sub>8</sub>(OH)<sub>8</sub>Cl

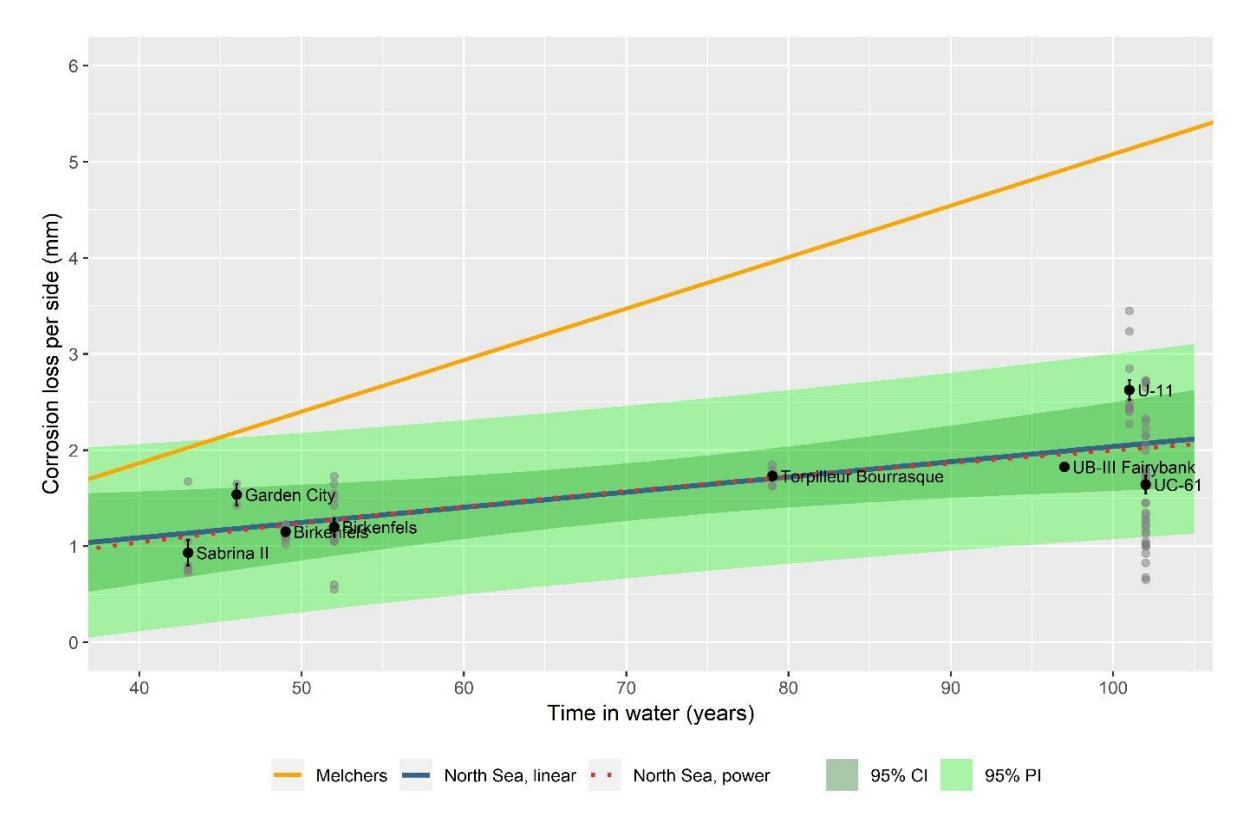
Figure 5. Corrosion loss per side (mm) versus time in the water in years; the blue line corresponds with the linear North Sea model with a green 95% confidence and prediction band; the orange line corresponds with the Melchers model as parameterized for the North Sea; the red dotted line corresponds with the North Sea power model.

The long-term linear part of the bi-modal model also was fitted to the data. Figure 5 shows that for the long-term evolution of average corrosion loss there is little difference between the linear and the non-linear model. A linear model could therefore be adopted to describe the long-term average corrosion loss

Comparison of the long-term linear model (displayed along with its 95% confidence and prediction bands in Figure 5) with the linear phase 4 of Melchers model (as defined in Figure 1) shows that the linear part of the latter hardly overlaps with the 95% prediction band of the measurements presented here. As such, the North Sea model is characterized by a long-term corrosion rate that is significantly lower than the long-term corrosion rate suggested by Melchers' multi-phase model. Once the corrosion becomes anaerobic and in the absence of active corrosion-accelerating bacteria, the corrosion rate in the North Sea, taken at 12.5°C, is estimated at  $r_s = 0.016$  mm y<sup>1</sup>. This is less than one third of the corrosion rate predicted by Melchers' multi-phase model, which is given by  $r_s = 0.054$  mm y<sup>1</sup> (Table 1).

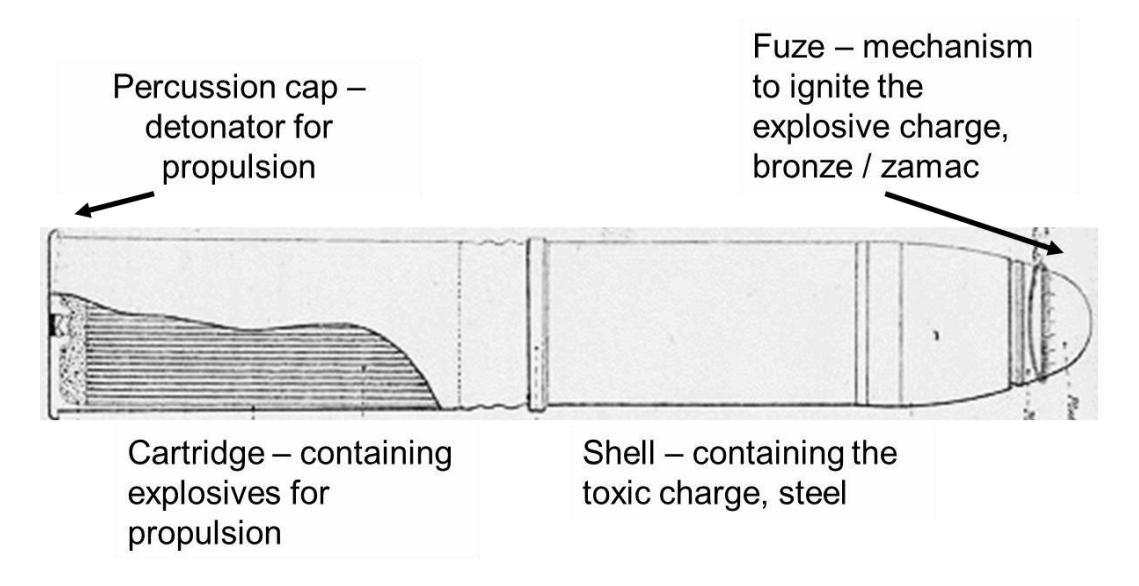
Figure 7. Structure of a German 77 mm gas shell. Original image in the public domain.

Five forms of corrosion may play a role. Firstly, each of the metal components of the shells (the cartridge, the shell and the fuze (Figure 7)), may be subjected to general, uniform corrosion. Additionally, galvanic corrosion may occur between the different metals, more specifically between the steel shell and the copper cartridge or the bronze fuze. For the shells the variability in the composition of the metals adds to the complexity of the problem. As the war progressed and raw materials grew scarce (Saul, 2012), any available material was used. German fuzes during World War I were made of brass, aluminium, steel or zinc (General Staff - General Headquarters, 1918). As the war progressed, less noble and more corrosive materials were used. If seawater can penetrate the shell, a reaction between water and the yperite (mustard gas) leads to the formation of aggressive hydrochloric acid, leading to an enhanced chemical corrosion from the inside out. Finally, erosion corrosion could have occurred before the ammunition was buried.
