Review

Causes and Controlling Factors of Valley Bottom Gullies

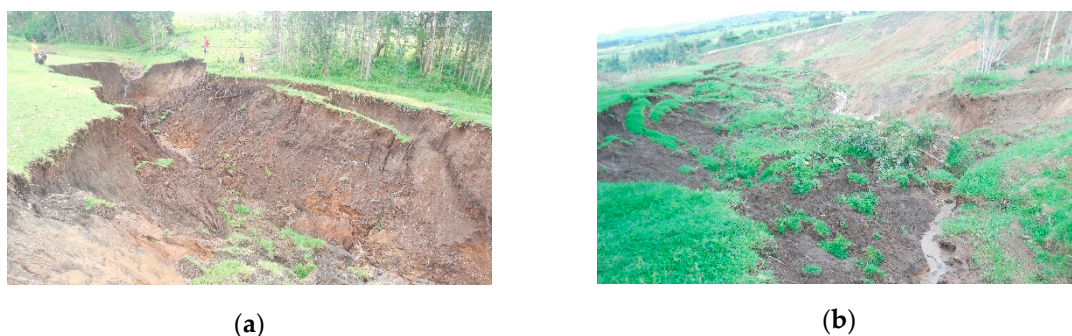
Figure 2. Schematic representation of typical valley bottom head-cut (a) and mass wasting phenomenon (b).

A combination of fluvial and mass wasting erosion mechanisms is responsible for the expansion of gullies at the valley bottoms [32,43,44]. Mass wasting and fluvial erosion progress through several stages to erode the gully banks [16,45]. (Stage 1) erosion of the bank toe is caused by the applied hydraulic shear stress or due to collapsibility, which is stress removal from the base and loss of cohesion due to increased pore water pressure. (Stage 2) This leads to steepening or an overhanging gully bank. The steepened or overhanging bank material then collapses (Figure 2a). (Stage 3) Fluvial erosion

removes the failed bank material, and the process (Stages 1–3) repeats itself until either more resistant bank material becomes exposed or the runoff is unable to erode and transport the collapsed bank material. Fluvial erosion may facilitate gully erosion in two ways: directly due to detachment of soil particles or gully head-cut retreat [16], and indirectly by triggering gully bank mass wasting through steepening of the gully bank [46].

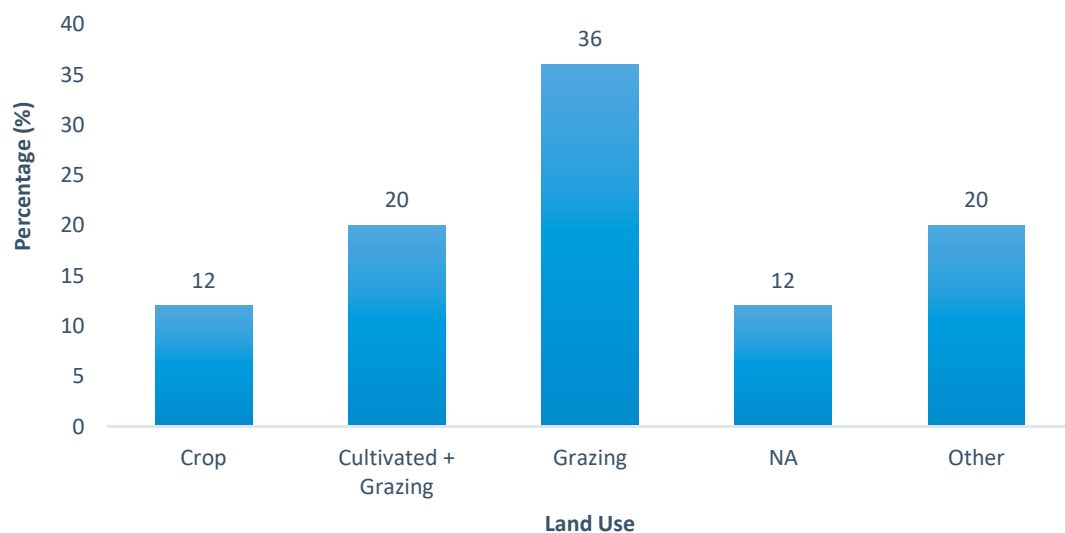
Figure 3. The percentage of articles, listed in Table 1, that state the specific land-use type in their VBG (valley bottom gully) studies. 'NA' (not available) denotes articles that do not report the land-use types of the gullied catchment. The 'others' land-use category includes land uses like brush and herbaceous.

Based on the data presented in Table 1, Figure 3 shows that 36% of the active gullies occurred in grazing land followed by combined crop and grazing land (20%) and other land-use (20%). Only 12% of the active gullies occurred in cropland. Likewise, in Italy [98,99], more gullies have been observed in grazing lands than croplands [18,65]. Valley bottom gully incision seldom commences in forest lands. Although these results seem to strongly point to a relationship between land-use and active gully development, the underlying reason is again the hydrology of the watershed as the grass is grown on soils that are too wet for growing crops [100]. Forest can be found in those parts of the landscape that are usually too dry for good crop yield due to the terrain steepness and/or restricted soil depth.
